# *Little Goose Dam*

## *Radial Gate Inspection and Testing*

US Army Corps of Engineers, Walla Walla District

13. ABSTRACT (Maximum 200 words) This report is an evaluation of the overall condition of the spillway tainter gates at Little Goose Lock and Dam, Snake River Washington.				
20030313 194

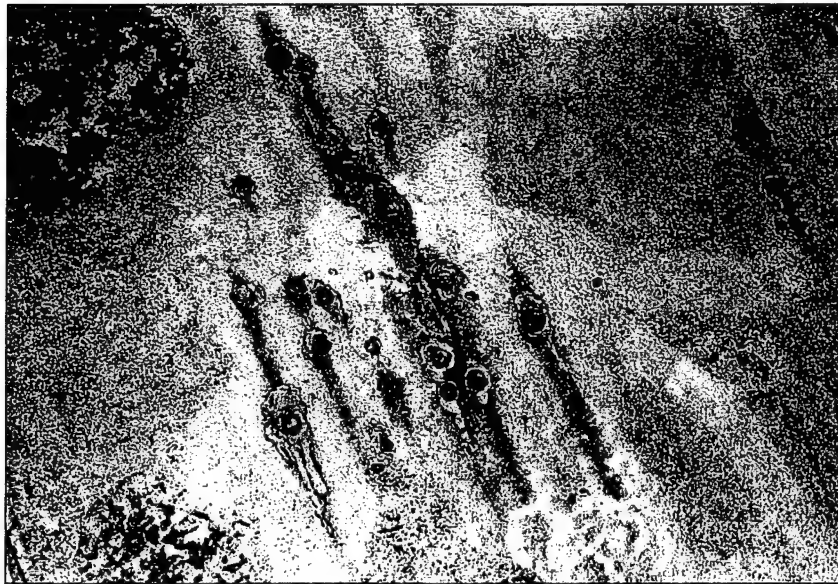
The condition of the upstream surface of the skin plate varies from generally good to extremely poor depending on the gate and the locations on the skin plate. On average, the pits are approximately one inch in diameter and 1/4-inch to 5/16-inch deep. Some appear to be greater than 1/4-inch deep in the 3/8-inch thick portion of the skin plate and greater than 3/8-inch deep in

***Photo. 5: Skin plate pitting, typical.***

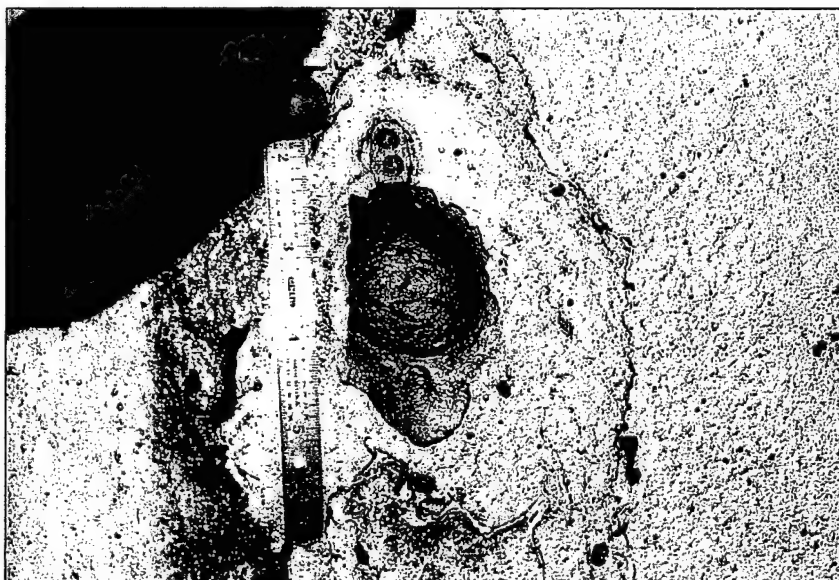
the 1/2-inch thick portion. See Figure 2, and photos 4 and 5. There is moderate to heavy, scattered pitting on the 3/4-inch wear plates on most of the gates. There is pitting present in excess of 1/2-inch deep at some locations, see Photo. 6. At many locations the pitting on both the skin plate and wear plates appears to be associated with scratches or dings in the plates original protective coating, see Photo. 5 and Photo 7. Based on the hemispherical shape of the pitting, the corrosion appears to be microbially influenced. It is likely that increased acid levels due to microbial activity have created a concentration cell within the pits and accelerated the corrosion.

***Photo. 6: Wear plate pitting - heavy, typical. Hemispherical shape is indication of microbially influenced corrosion.***

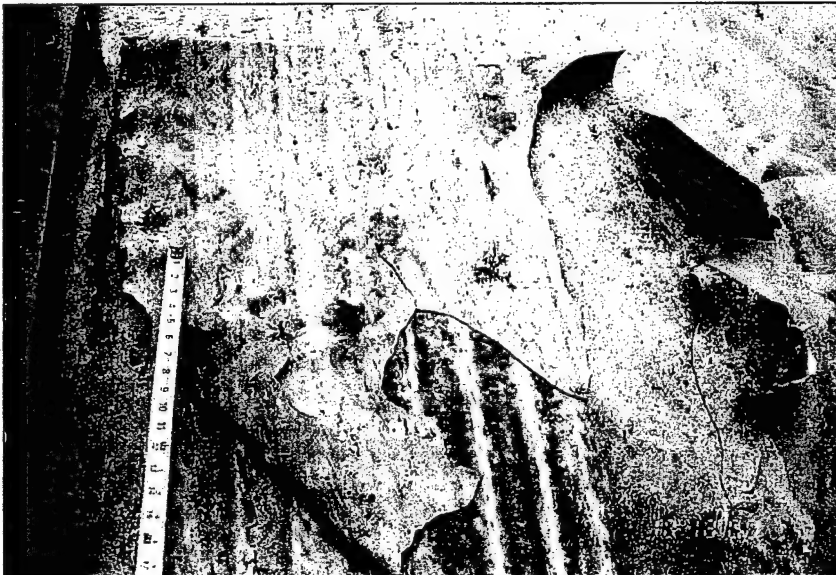
There is significant delamination of the vinyl coating on the wear plate at Gates 2 and 6 with smaller spots of delamination at other gates. See Photo. 8.

**Photo. 8:** *Delamination of vinyl coating on wear plate, typical Gates 2 and 6.*

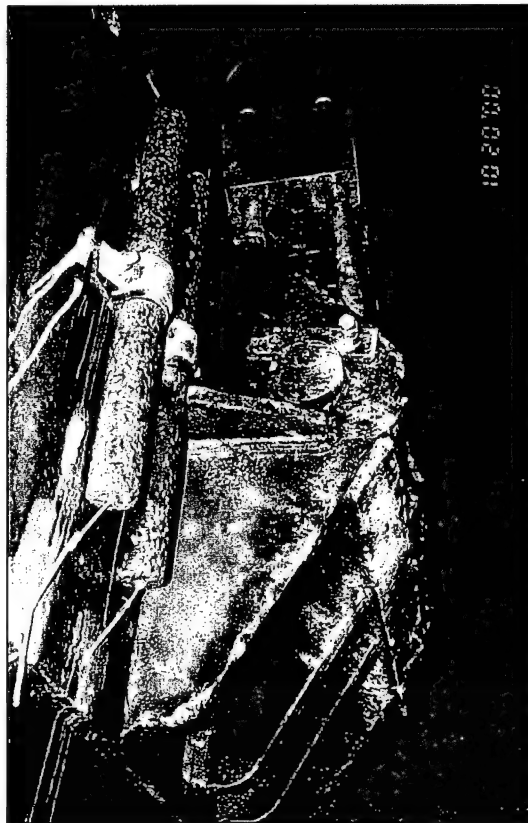
The hoist connections are in generally good condition with light to moderate corrosion present on the lifting lug plates. The U-bolts, socket blocks and connection pin, which appear to be stainless steel, are in very good condition, see Photo. 9. The design or material type for the U-bolts, socket blocks and connection pin are not listed in the available plans. The sacrificial anodes appear to be in too good of a condition given their installation date of 1981 and 1982. It is likely that they were painted or in some way protected after their installation and ceased functioning as anodes.

***Photo. 9: Hoist connection, typical condition.***

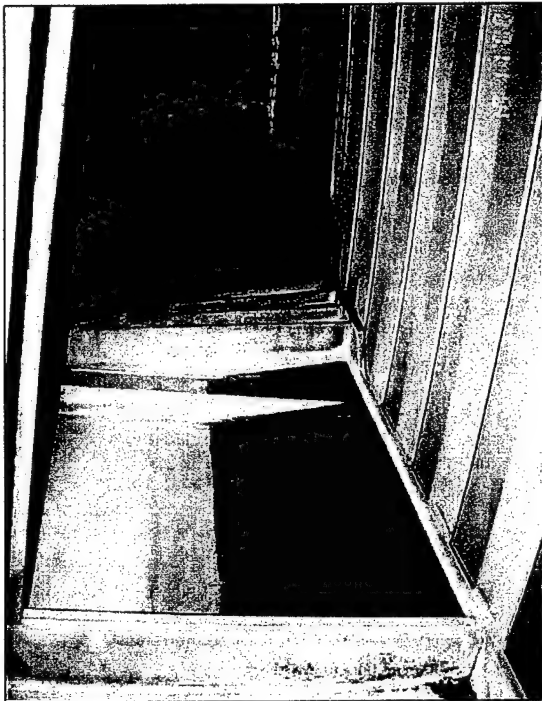
**Photo. 12: Standing water or debris lines between stiffeners at ends of bottom horizontal girder, typical.**

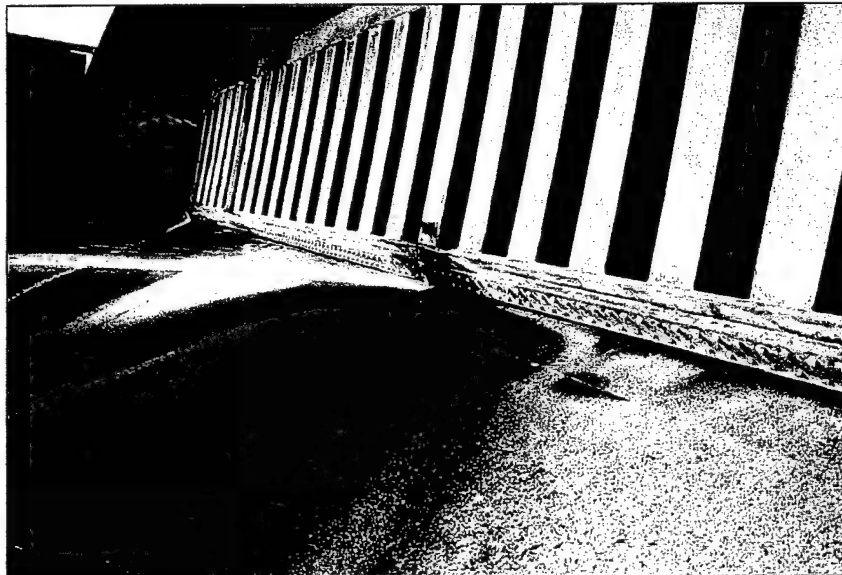
The side and bottom seals are in generally good condition. Small side and bottom seal leaks are visible on many of the gates, although no major leaks were observed. There is a leak at the bottom seal, at the spillway monolith construction joint at nearly every gate, see Photo. 17. There is light to moderate corrosion on the downstream side of the skin plate at the side seals and side seal bolts, see Photo 19.

***Photo. 17: Leak at spillway monolith construction joint, typical.***

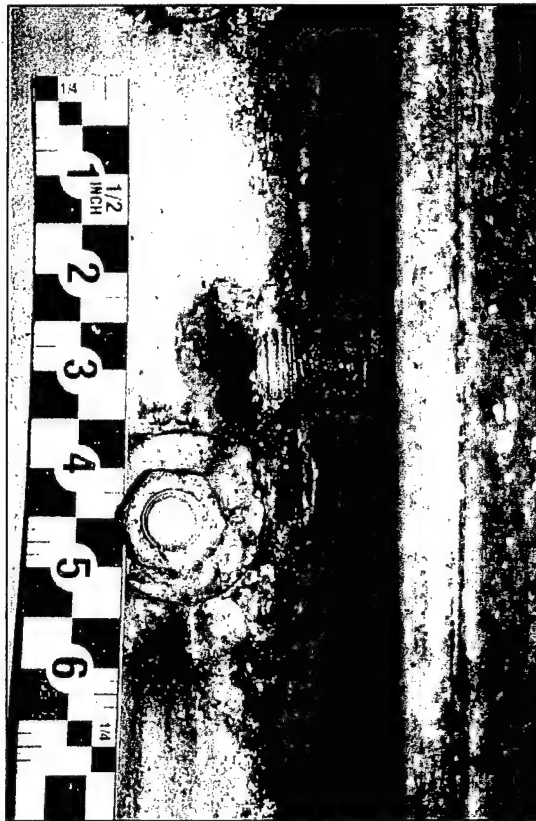
**Photo. 18: Side seal from downstream side, light to moderate corrosion on skin plate, seal angles, nuts and bolts, typical condition.**

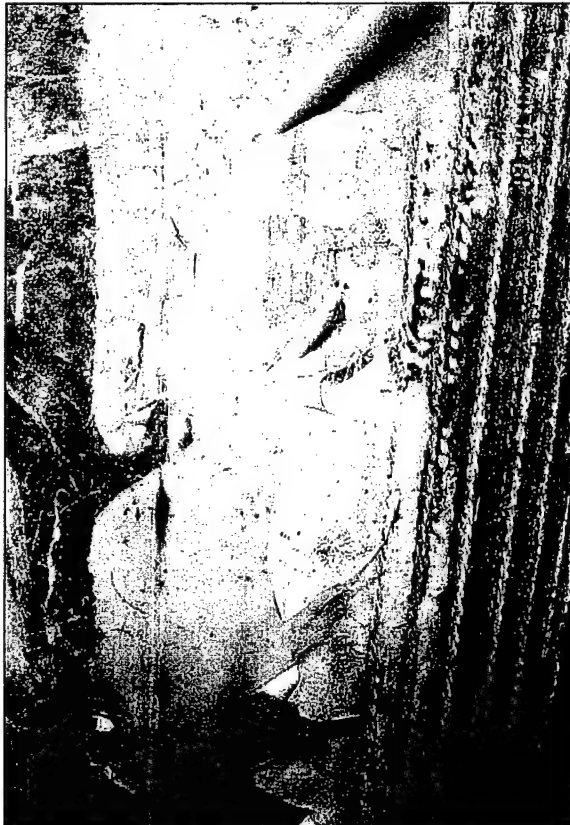
- On the downstream side of the skin plate, along the wear plate, there is delamination of the vinyl coating on the plate. Large sheets of vinyl are peeling off of the wear plate and hanging loosely on the gate face.

***Photo. 23: Delaminated  
vinyl coating  
on wear plate,  
right side of  
Gate 2.***

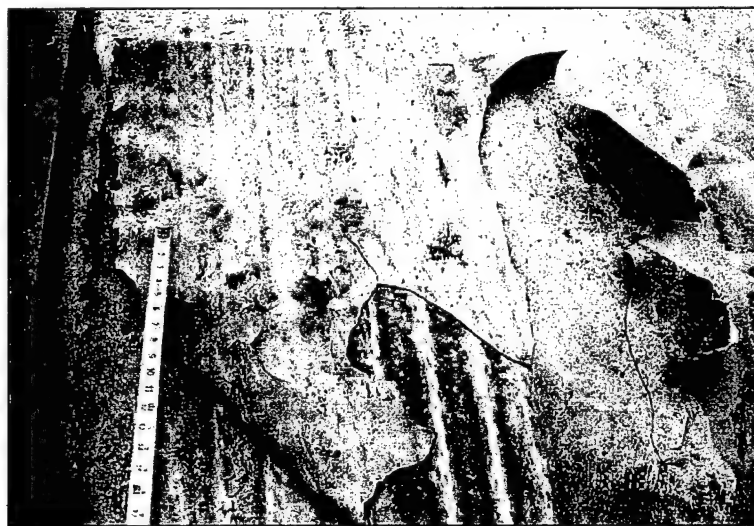
- On the downstream side of the skin plate, along the wear plate, there is delamination of the vinyl coating on the plate. Large sheets of vinyl are peeling off of the wear plate and hanging loosely on the gate face.

***Photo. 28: Delaminated vinyl coating on wear plate, left side of Gate 6.***

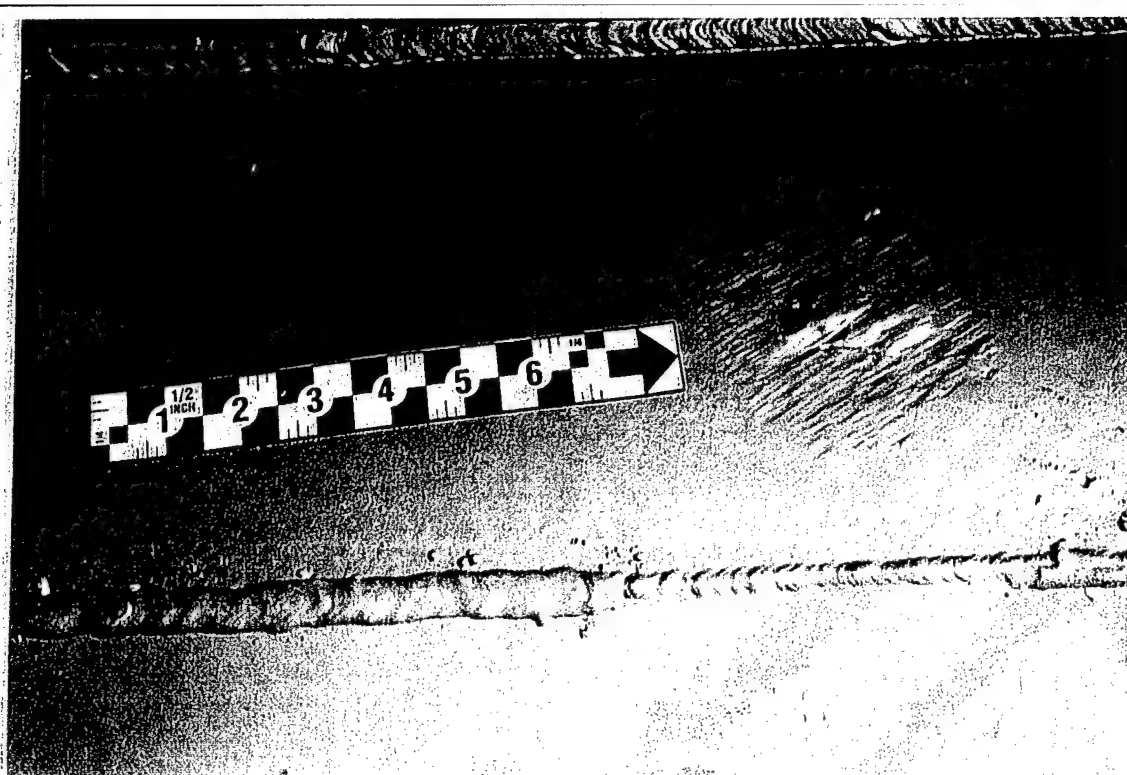
Skin plate at center of gate, 5' above  
top horizontal girder. Apparent  
previous weld and grind repair.

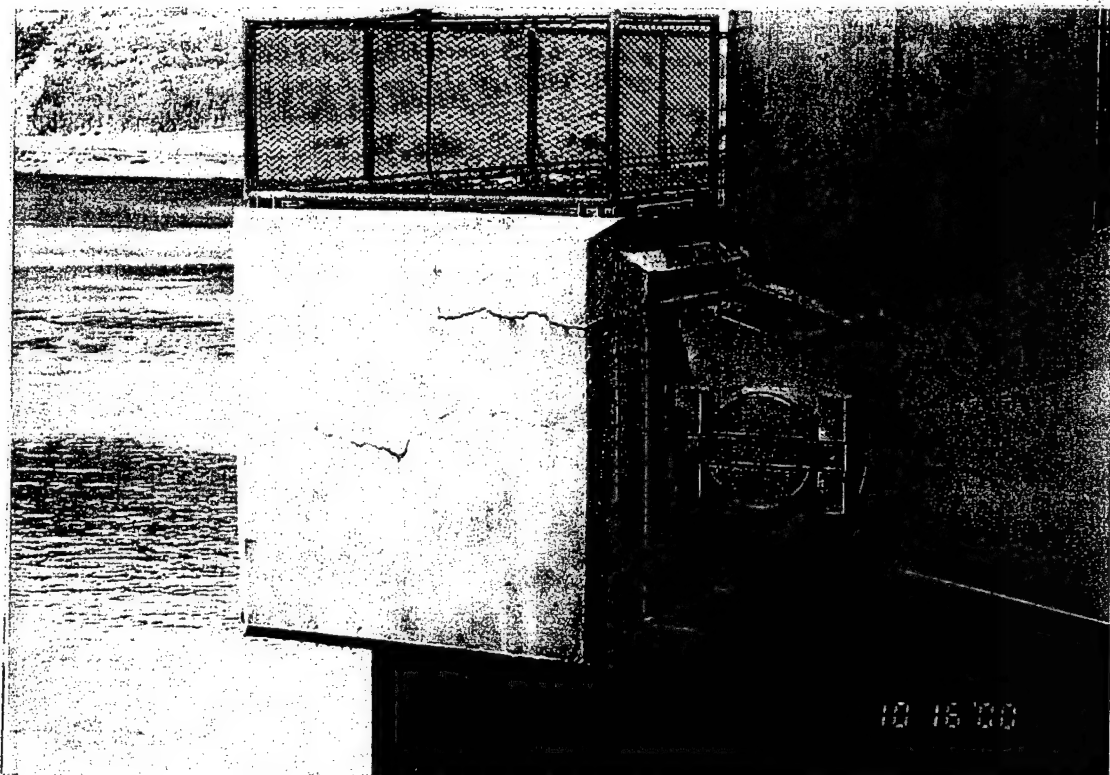
Right trunnion block. Light cracking  
in concrete.

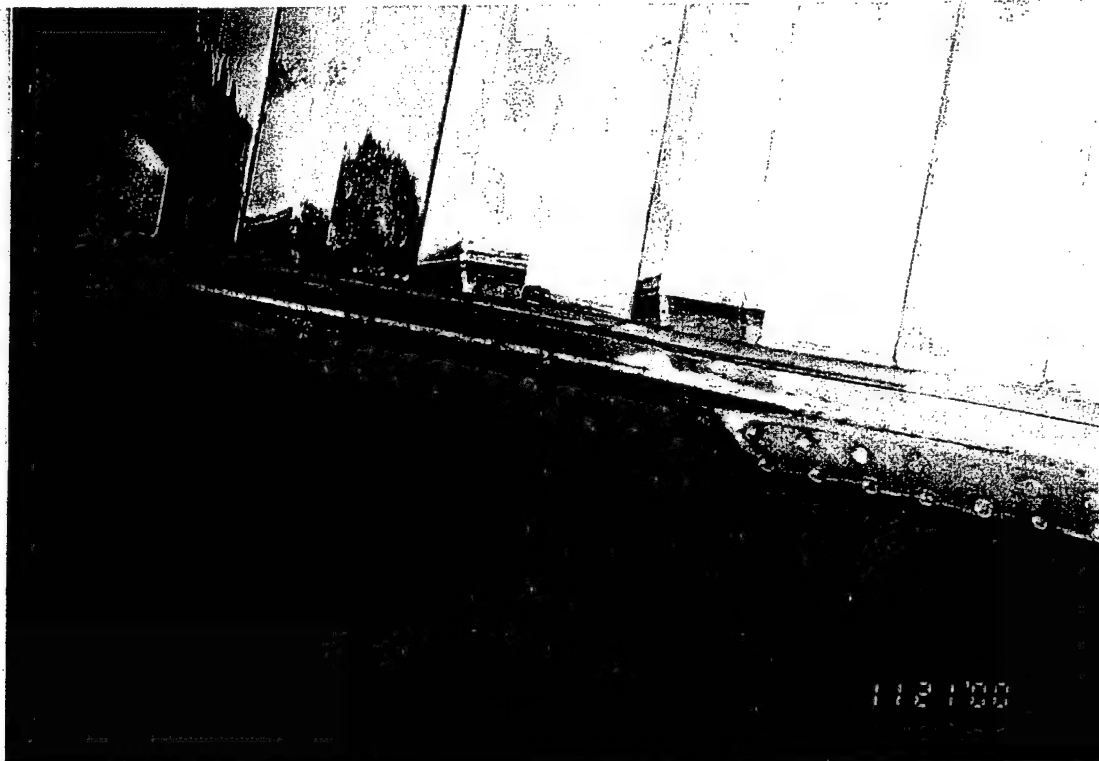
Skin plate pitting, typical.

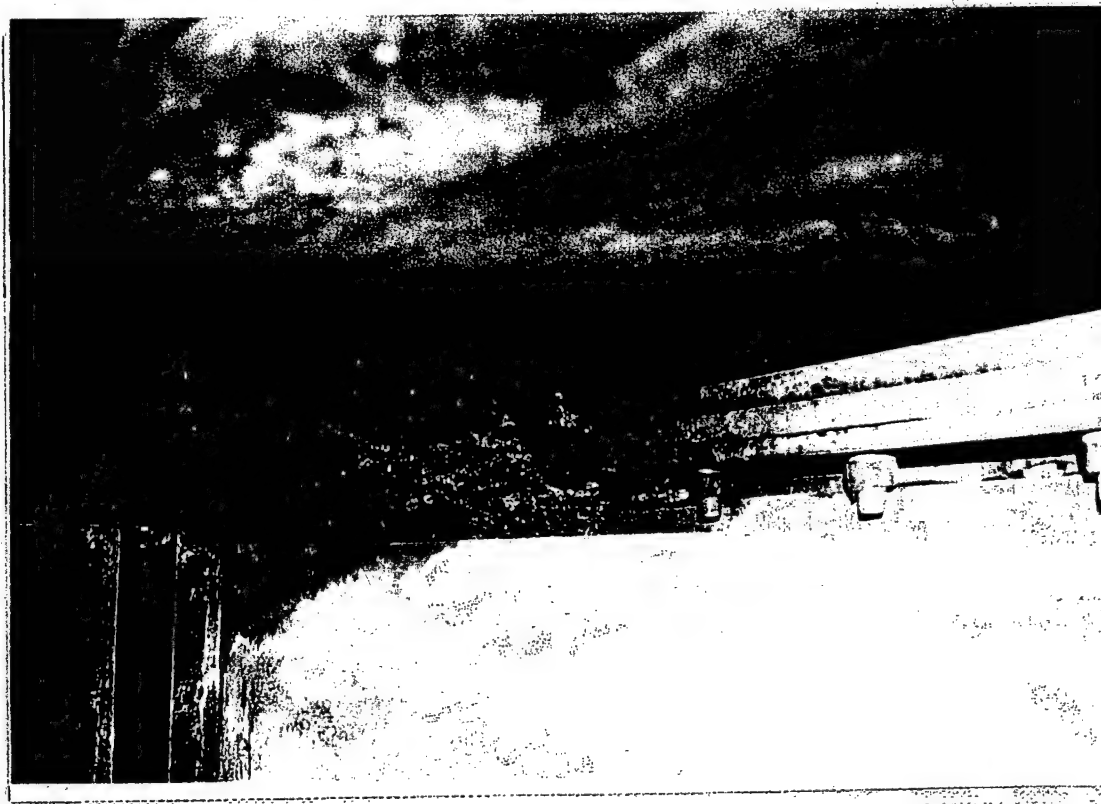
Bottom horizontal girder, left end.  
Standing water, no drainage between  
multiple stiffeners, typical.

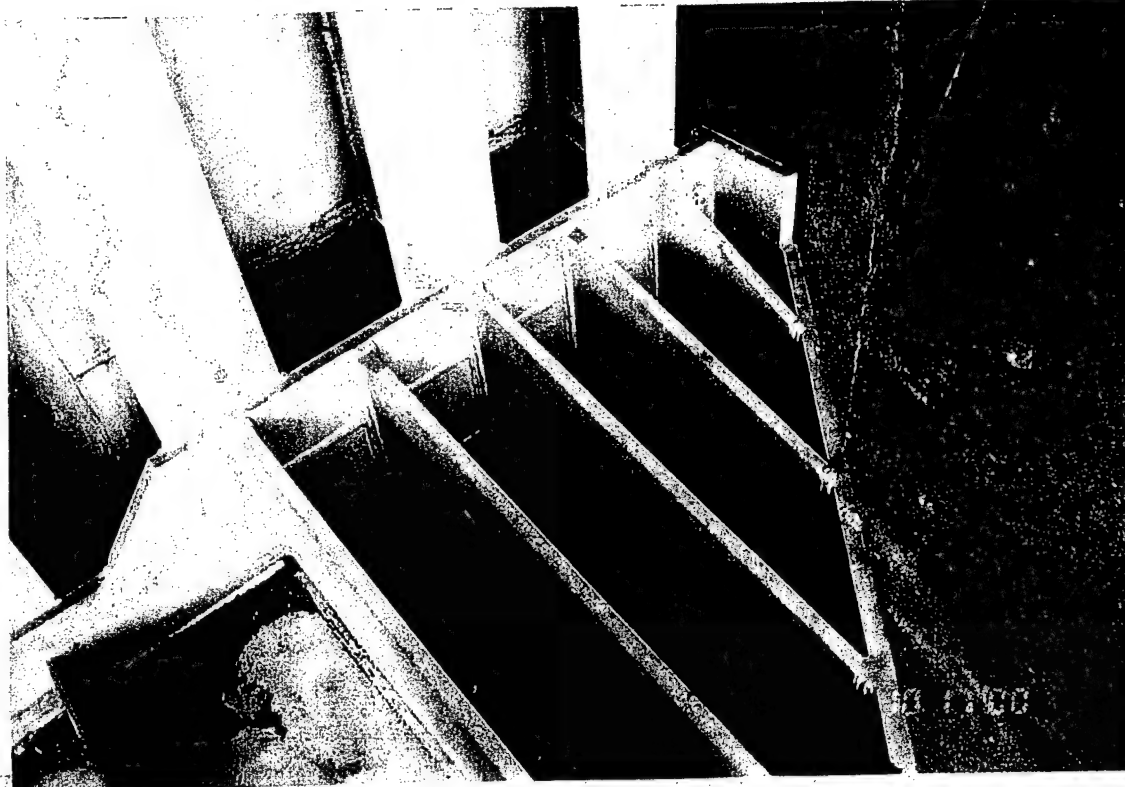
2-10

**Gate 2**  
Left frame between brace J and K.  
Debris at upstream end of bottom  
radial strut.

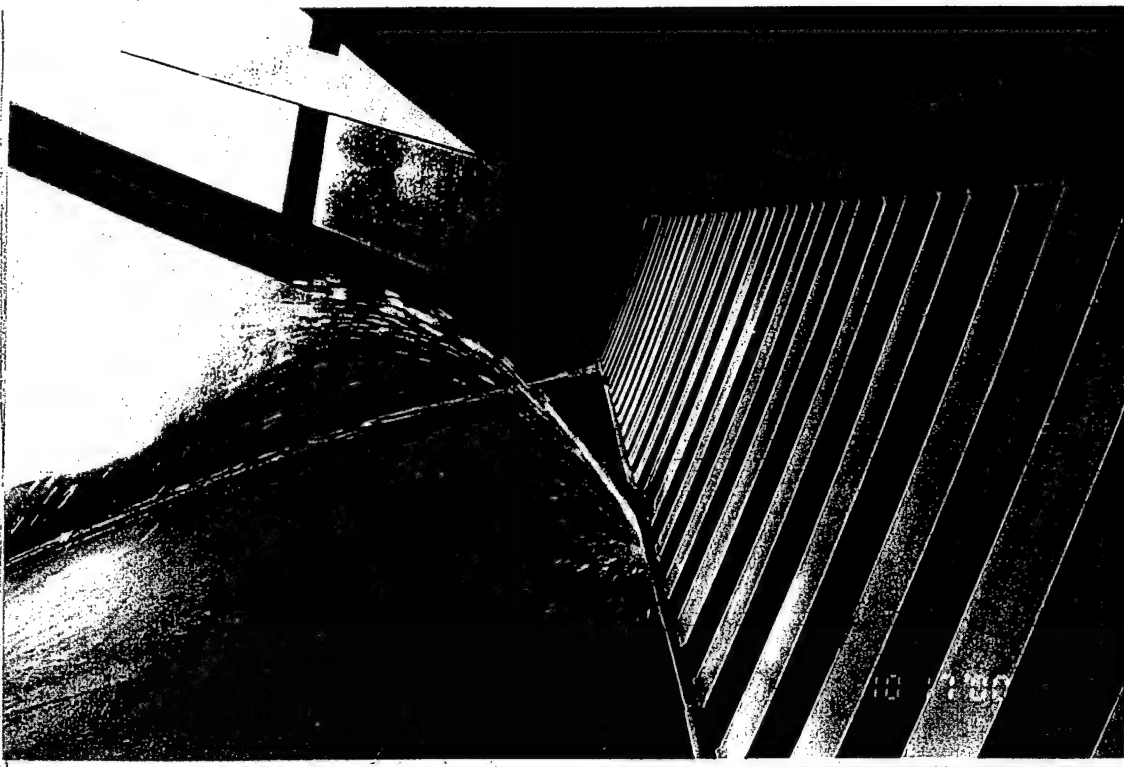
2-14

Gate 2  
Leak, bottom left corner of gate.  
Bottom seal closure plate. Standing  
water between closure plate, purlin  
webs and skinplate. Typical.

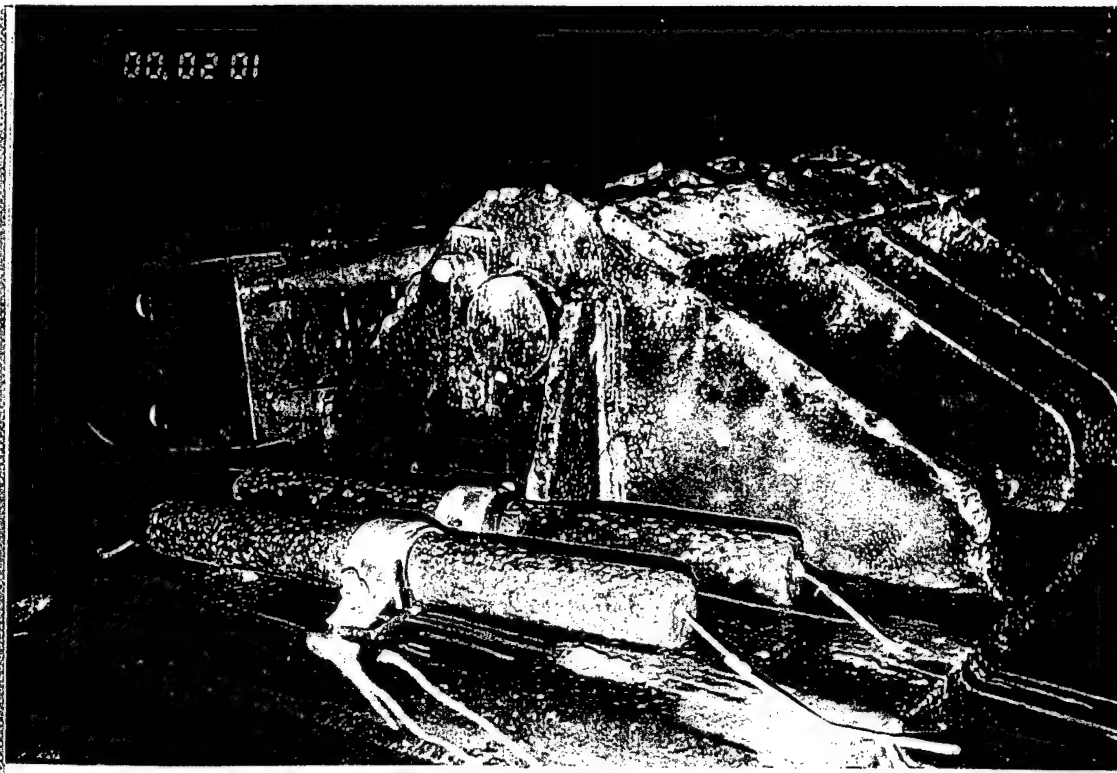
2-22

Gate 2  
Bottom seal, typical.

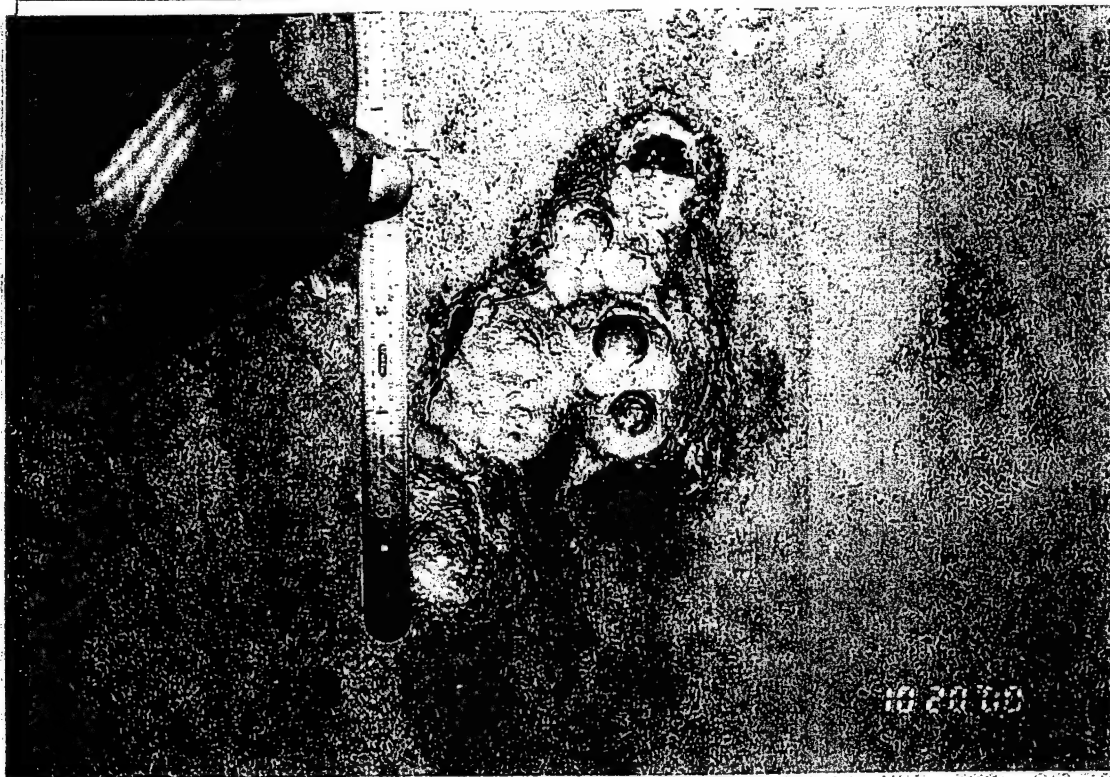
2-29

Gate 2  
Skin plate pitting, typical.

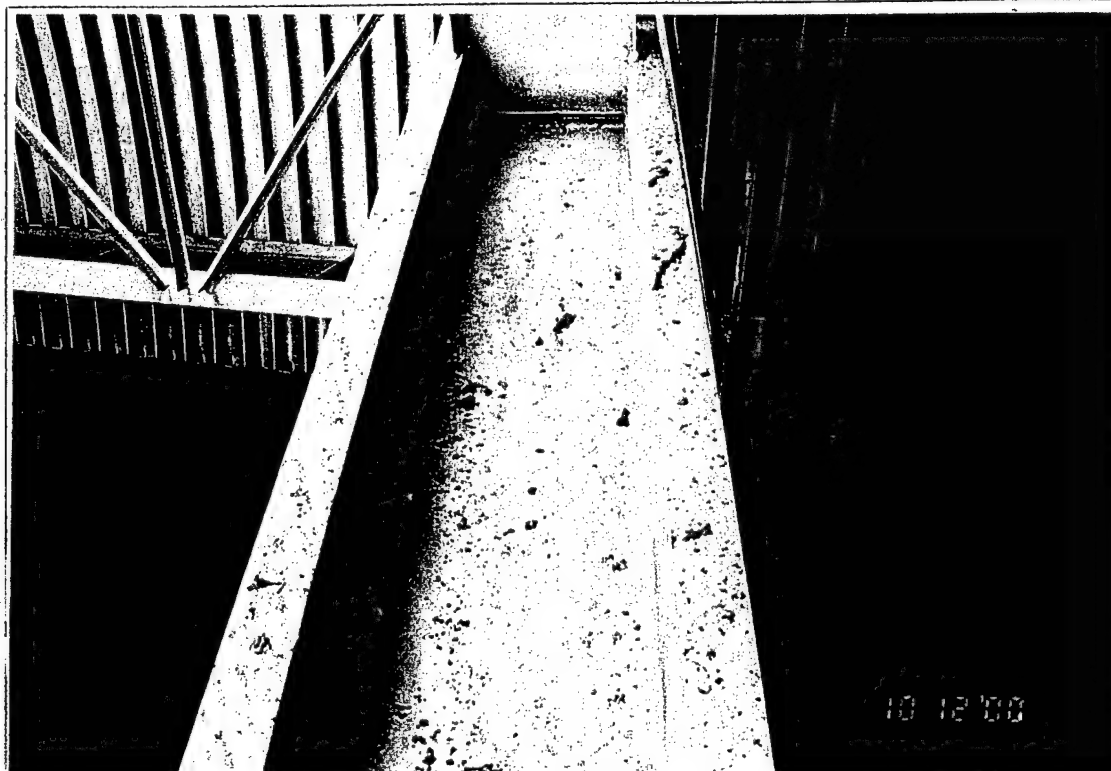
3-1

Gate 3  
Left side of gate. Light corrosion on  
members.

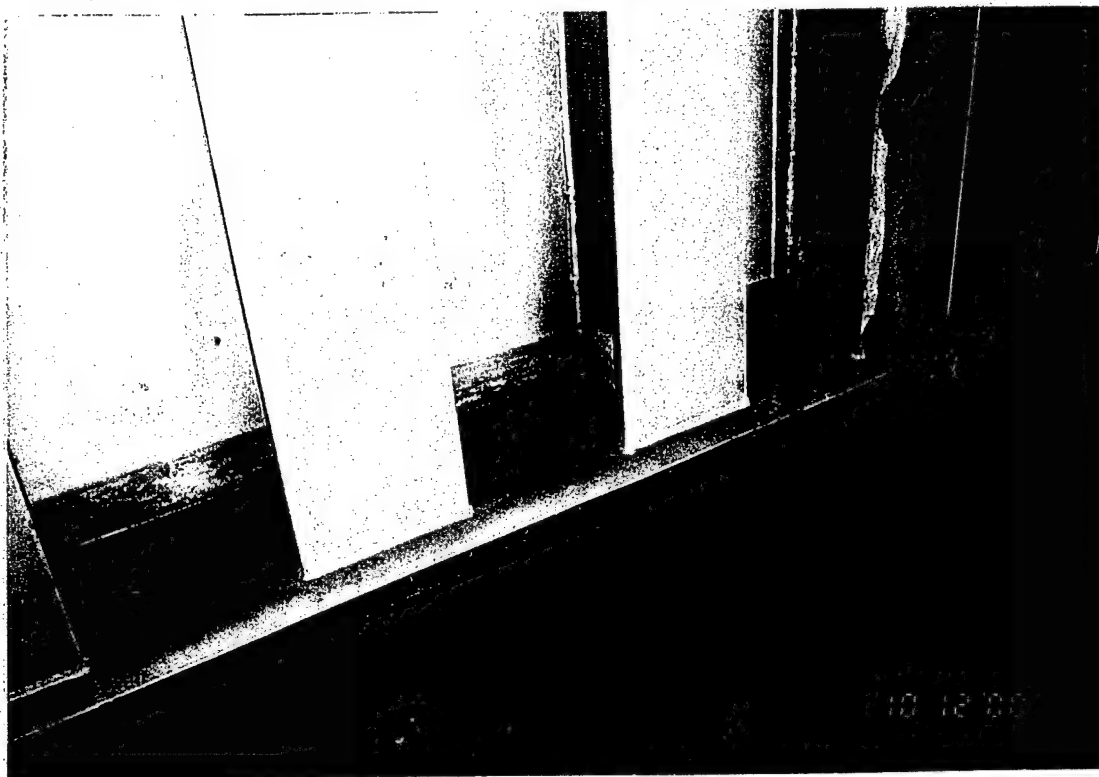
#### Gate 3

Standing water between closure plate, purlin webs and skinplate, typical.

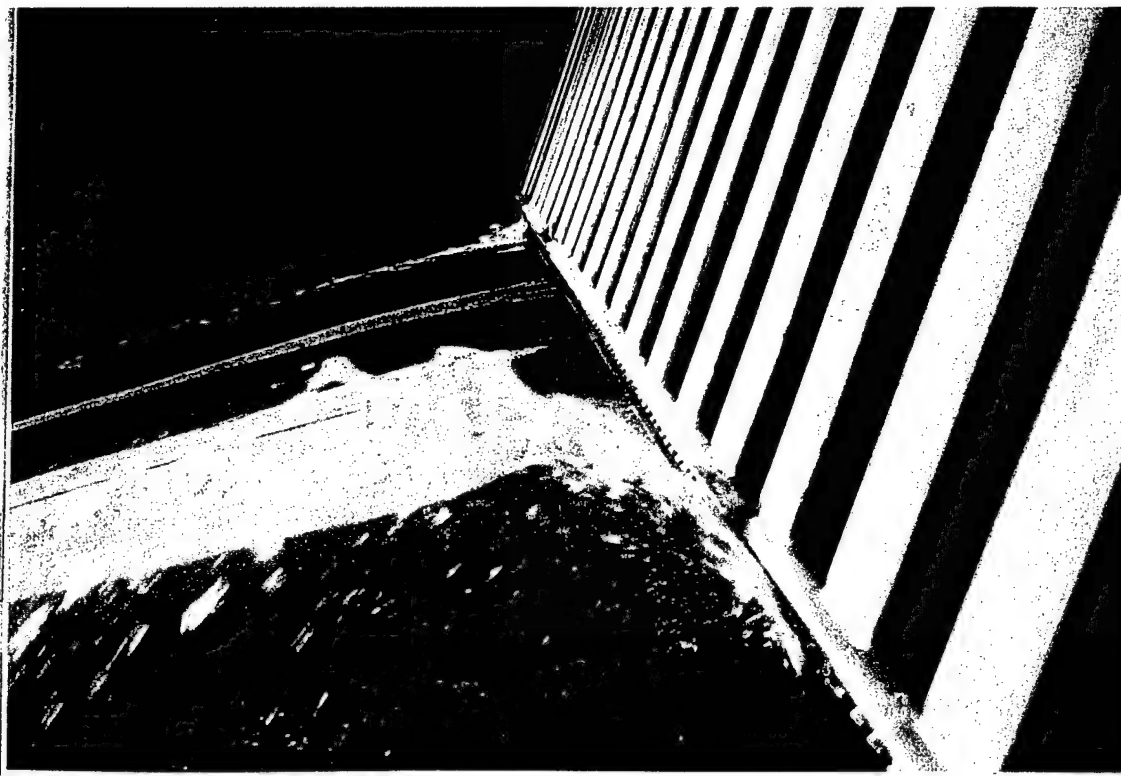
3-11

**Gate 3**  
Leak at center construction joint in  
spillway monolith.

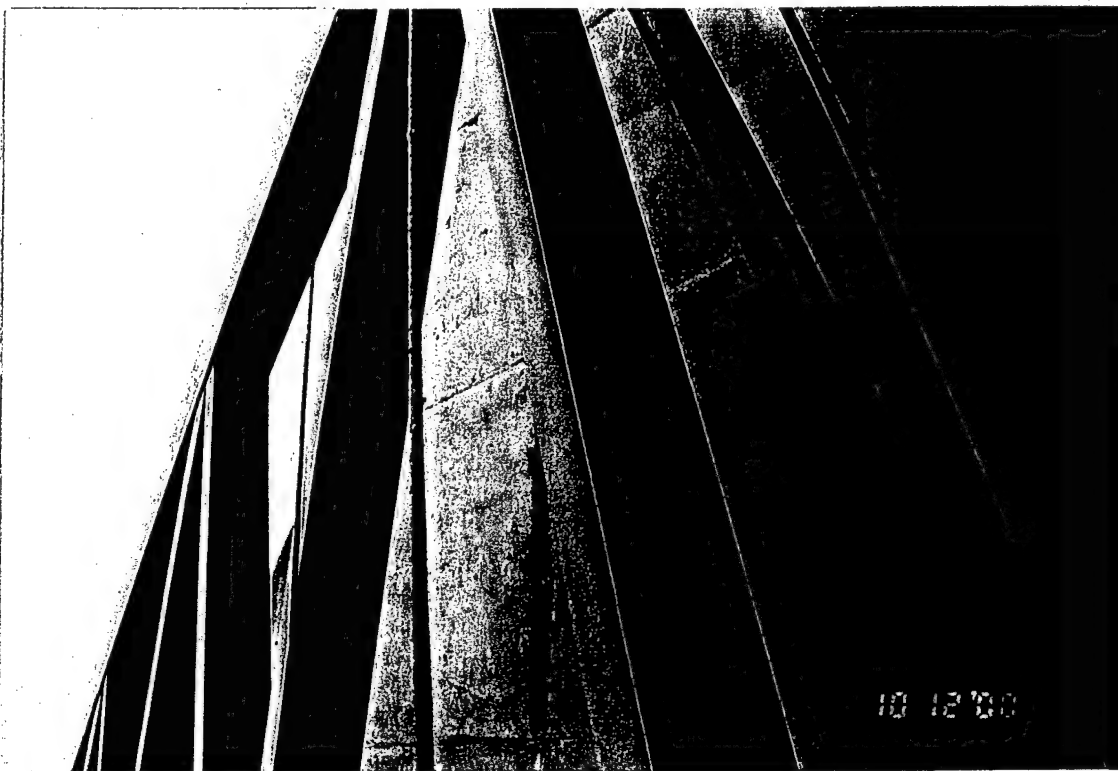
Gate 3  
Bottom side of right frame, typical.

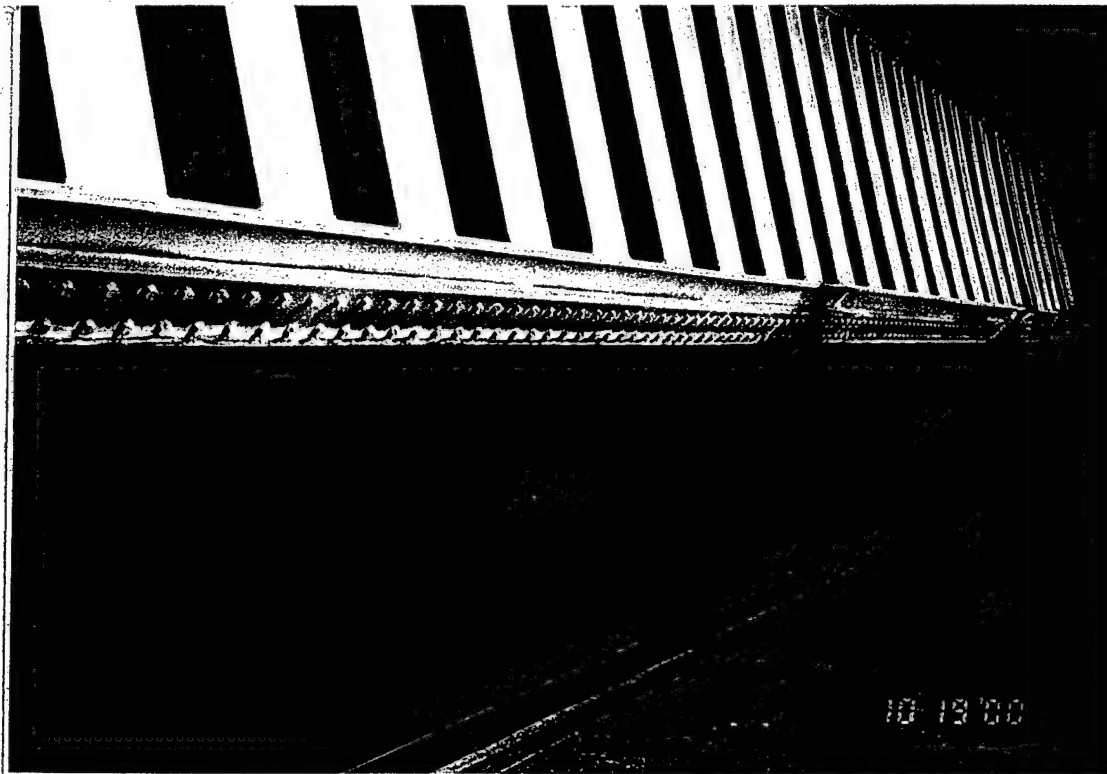
Bottom of left side of gate at 3' open.

Note: Heavy falling water due to stop log leakage precludes inspection of hoist connections.

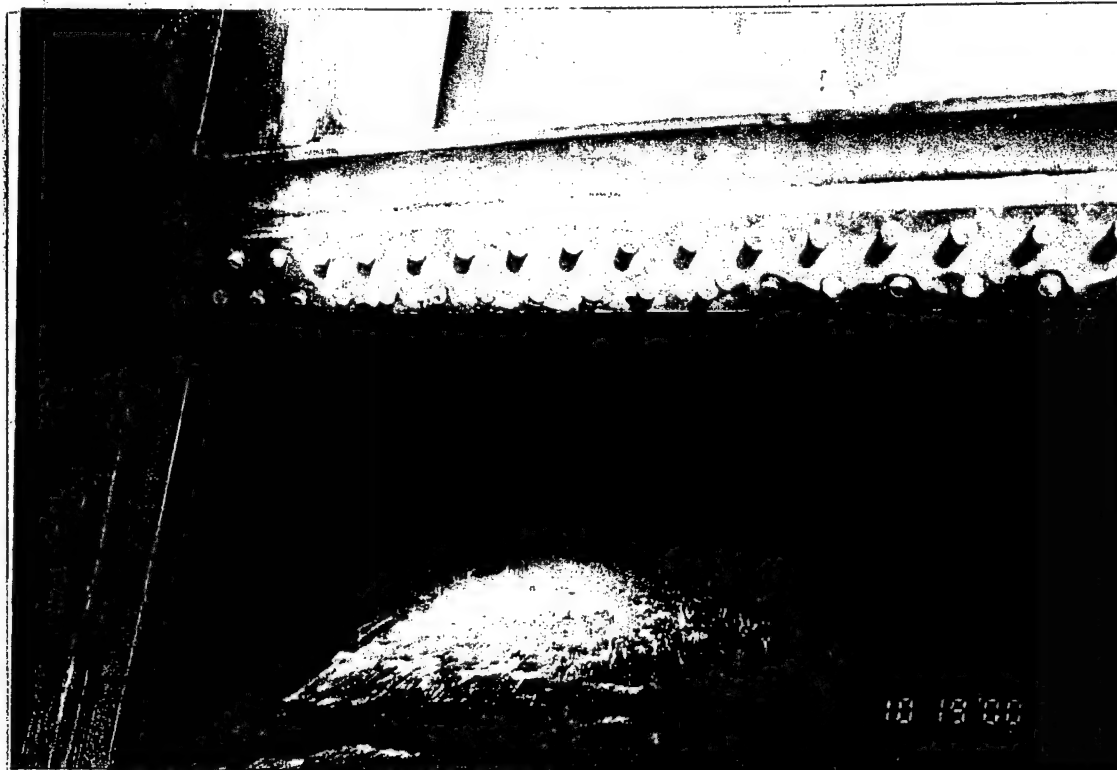
Bottom of right side of gate at 3' open.

Note: Heavy falling water due to stop log leakage precludes inspection of hoist connections.

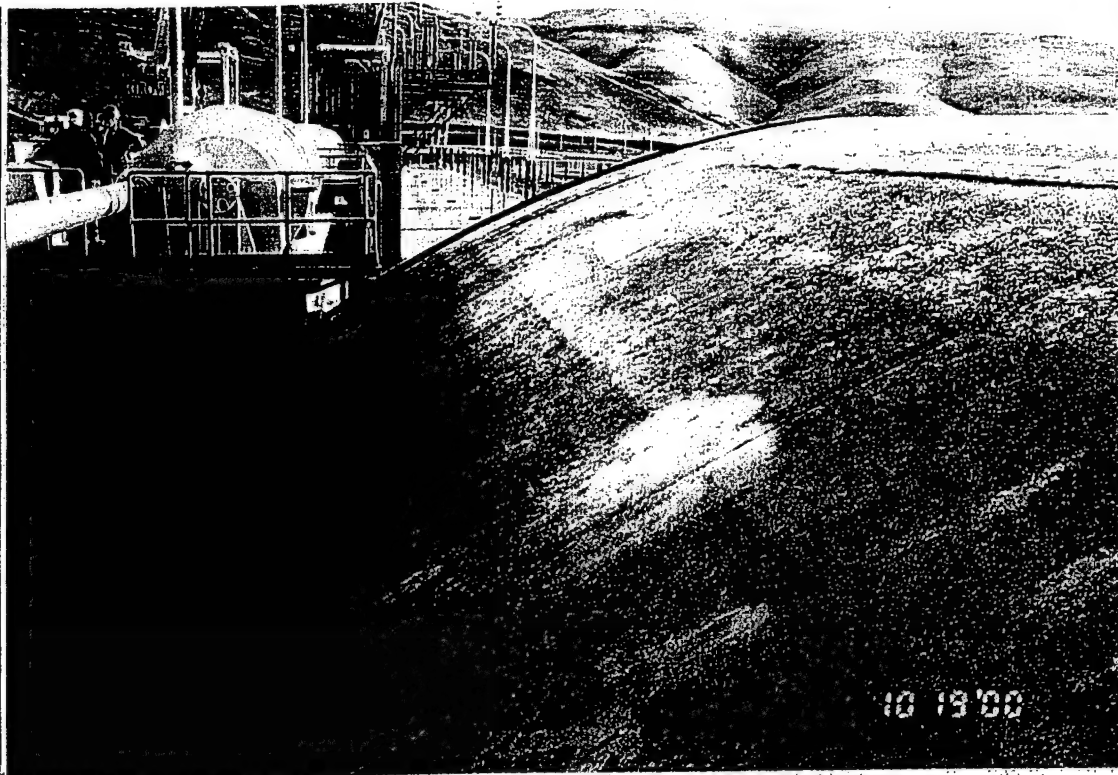
**Gate 3**

Skin plate condition, typical.  
Minimal pitting.

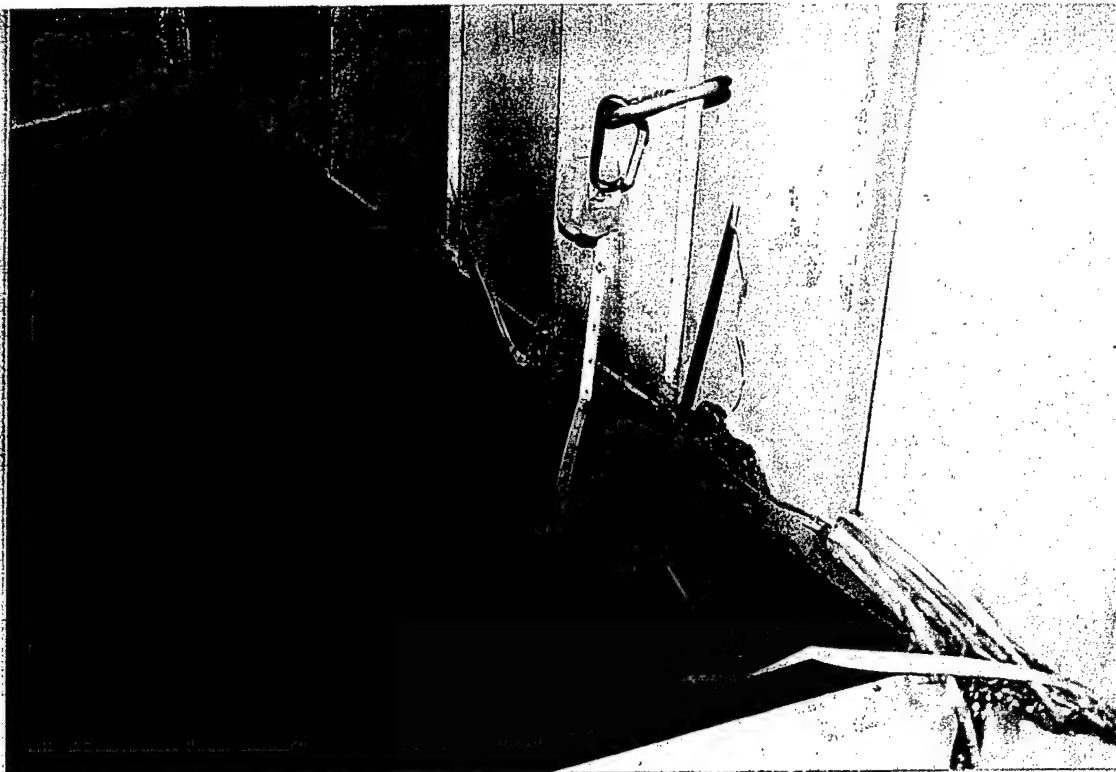
#### Gate 4

Bottom horizontal girder, right side.  
Standing water, no drainage between  
multiple stiffeners, typical. Side seal  
leak.

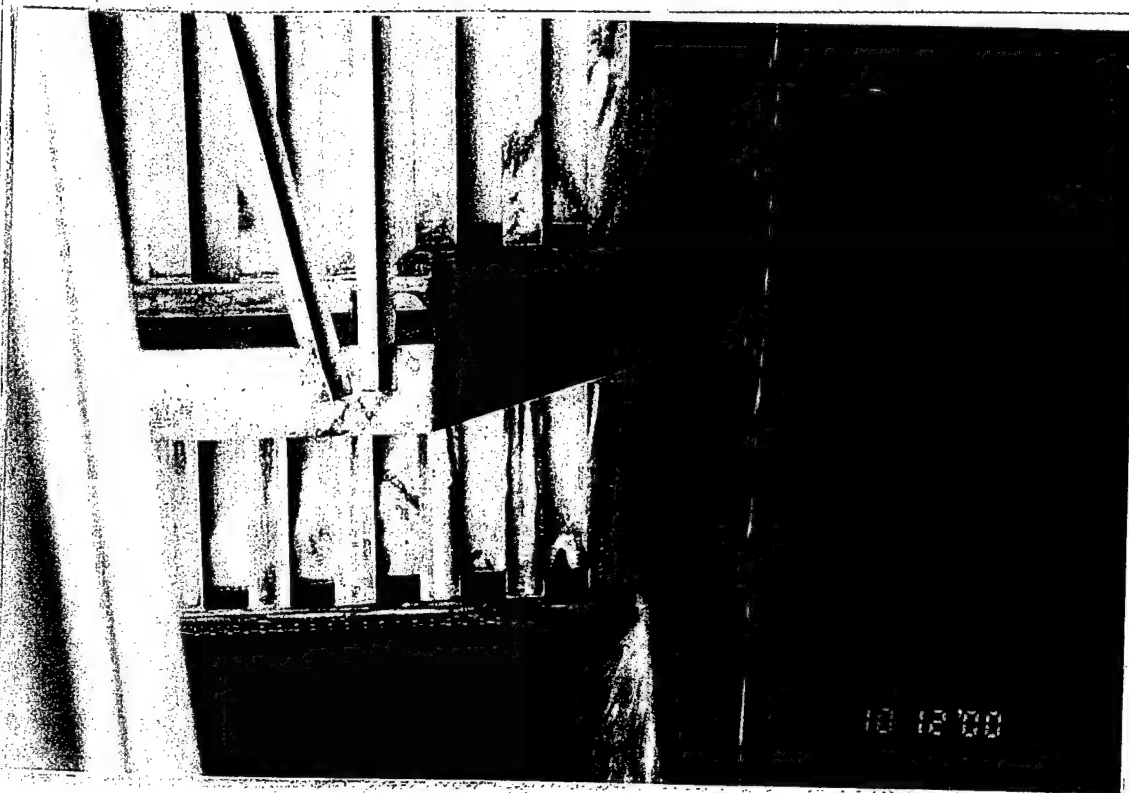
4-20

Gate 4  
Bottom horizontal girder, left side.  
Standing water, no drainage between  
multiple stiffeners, typical. Side seal  
leak.

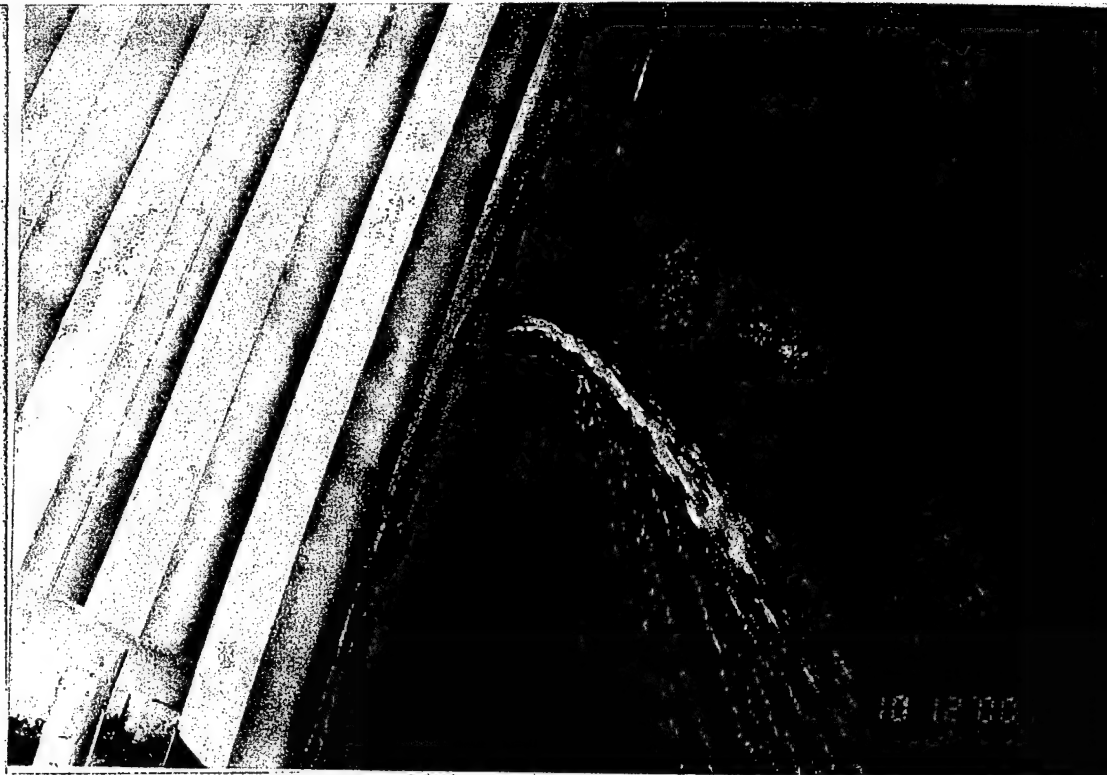
4-21

Gate 4  
Side seal leak, left side of gate.

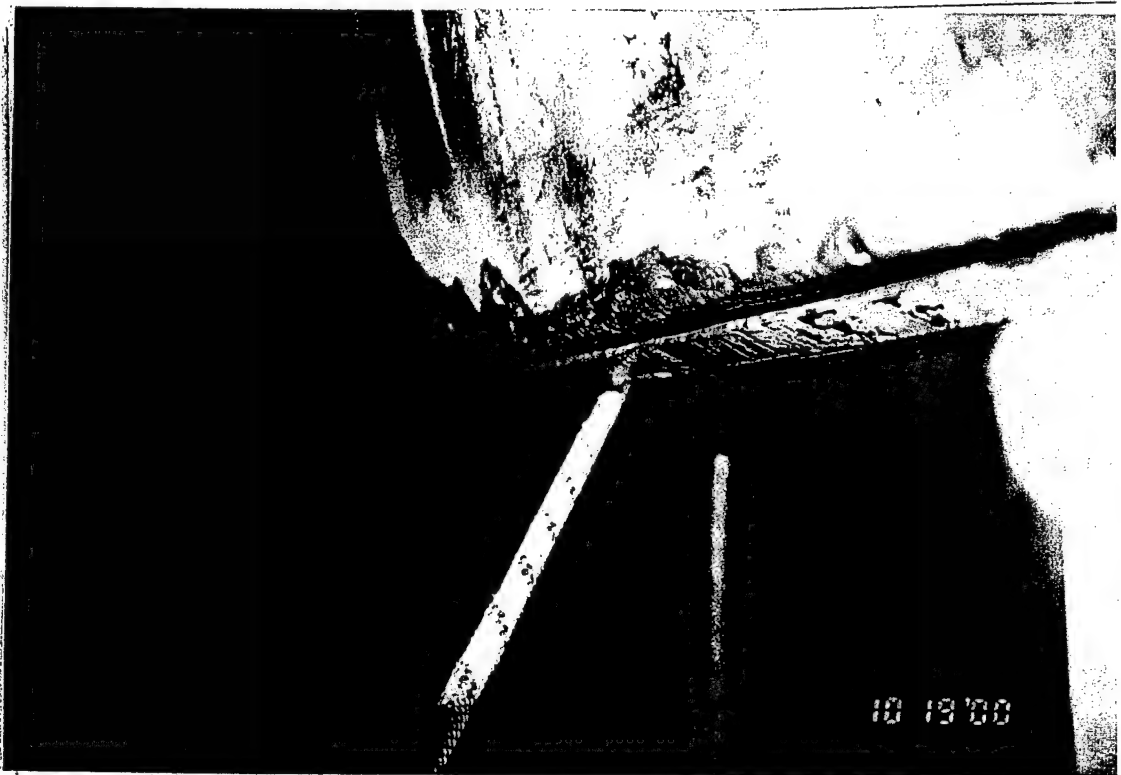
4-30

**Gate 4**  
Bottom seal and bottom upstream  
side of skin plate. Moderate  
corrosion at bottom edge of skin  
plate.

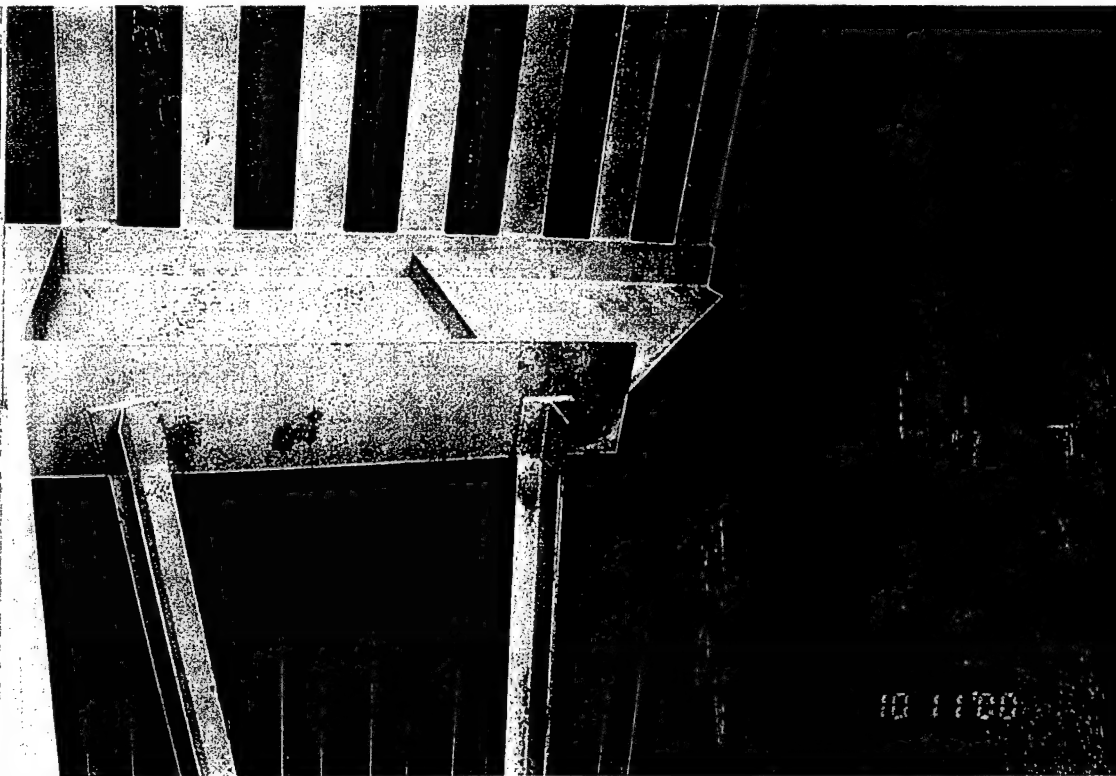
Downstream side of skin plate, left  
side of gate, above top horiz. girder.  
Peeling paint, light corrosion.  
Appears to be possible paint blister  
due to upstream skin plate welding.
